Re: **CBKN Dirtworks/ Southwest New Mexico Regional Landfill Cells 1-4 Final Cover Construction; CGP; SIC 1629; NPDES Compliance Evaluation Inspection; NPDES #NMR1000QD; January 17, 2018**

NPDES Construction General Permit Inspection Report – State of New Mexico

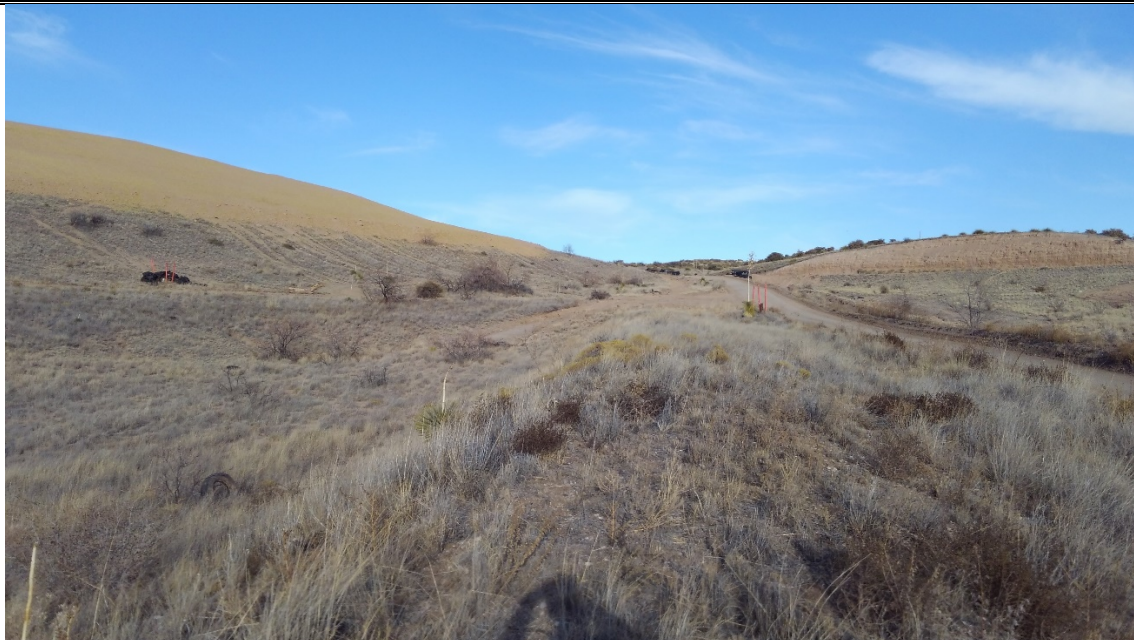
NMED/SWQB Official Photograph Log Photo # 1		
Photographer: Jennifer Foote	Date: 1/17/18	Time: 3:53 pm
City/County: Silver City/Grant Co.		State: New Mexico
Location: Southwest Regional Landfill		
Subject: Landfill closure project on left, retention pond in foreground.

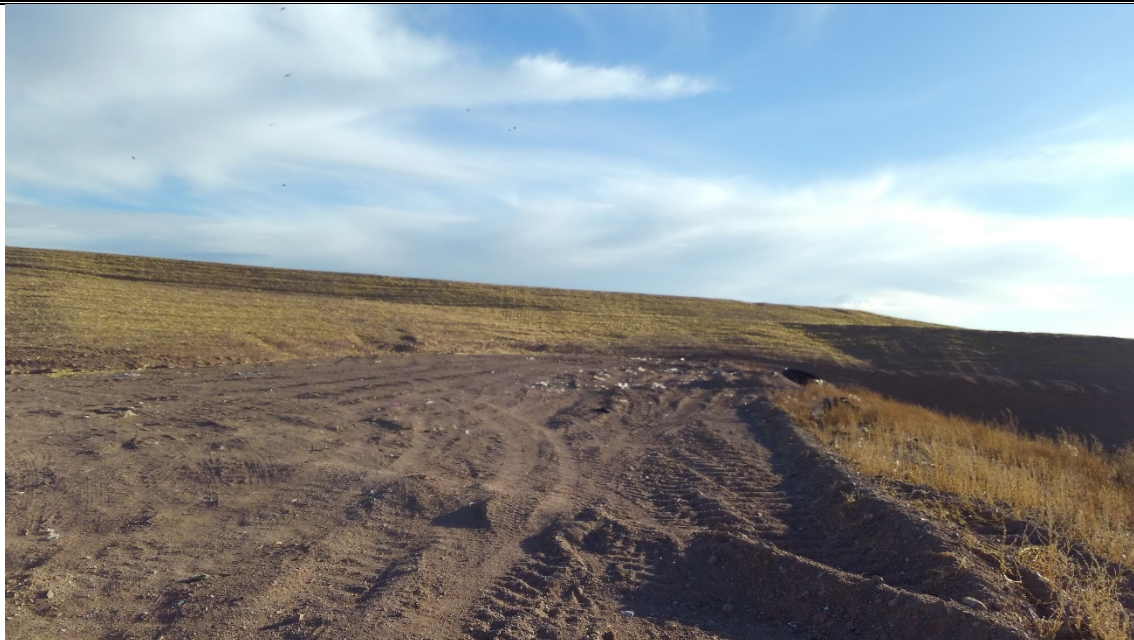
The new landfill closure cover appeared to have had stabilization initiated with straw mulch cover, it was unknown if it was seeded. Final stabilization is achieved when the site has Established uniform, perennial vegetation (i.e., evenly distributed, without large bare areas) that provides 70 percent or more of the cover that is provided by vegetation native to local undisturbed areas. No other construction BMPs were observed, and the contractor appeared to be completely demobilized from the site.

NMED/SWQB Official Photograph Log Photo # 2		
Photographer: Jennifer Foote	Date: 1/17/18	Time: 4:14 pm
City/County: Silver City/Grant Co.		State: New Mexico
Location: Southwest Regional Landfill		
Subject: Closure project stabilization initiated with straw mulch
